## Rehabilitation of Galena's 1858 historic post office and customhouse: relocation of the Galena-Jo Daviess Historical Society and Museum

**MASTER OF ARCHITECTURE**

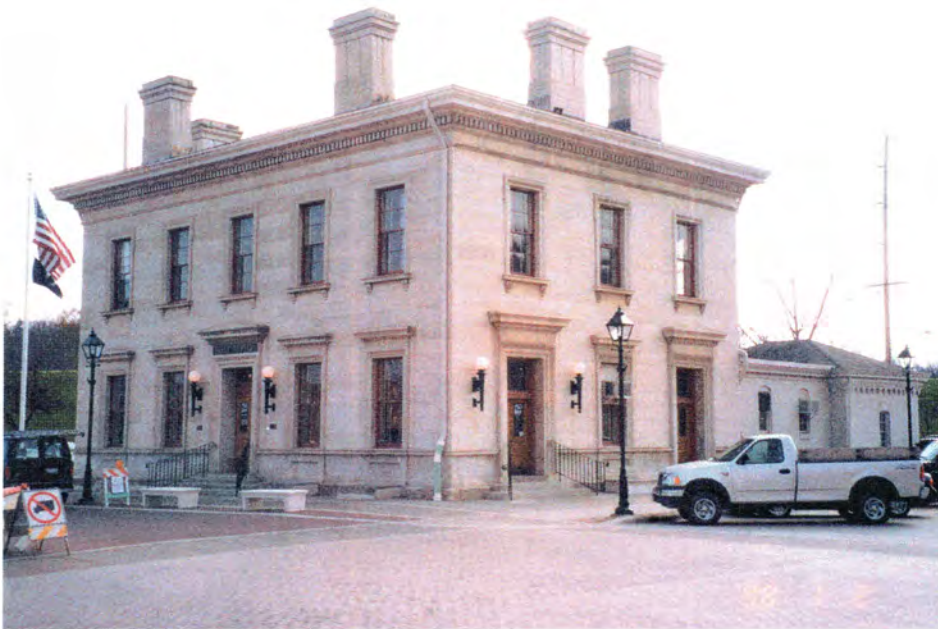
Galena, Illinois, has the distinction of possessing the nation's oldest continually operating post office, constructed in 1858 (Figure 1). The title was previously held by a post office in Castine, Maine, which ceased operations in 1998.<sup>1</sup> Knowing the value of this historic building, the City of Galena built a newer post office in 1996 that handles most of the

**Figure 1. Galena's Historic Post Office and Customhouse**

The post office and customhouse is located on Commerce and Green Street, one block from Main Street (Figure 1). Constructed of limestone, brick, concrete, and steel framing members, it is two stories tall. Metal columns support the interior with decorated capitals near the ceiling. The exterior load bearing walls are constructed of limestone and brick. The limestone on the exterior came from a quarry in Nauvoo, Illinois, renowned as one of the best in the Midwest for its impeccable quality (Figure 6).

In 1907, the original limestone balustrade wrapping the perimeter of the post office roof was removed (See Appendix A, “Drawing 3 & 5”). The original corrugated metal roof was significantly altered from Young’s design when an additional asphalt-shingled structure was built on top of existing metal truss roof to increase the slope (See Appendix A, “Drawing 4”). In Figure 1, the asphalt-shingled structure remains with eight silhouette chimneys.

The most significant view of the post office is from Green and Commerce Streets from the northwest corner (Figure 1). Positioning the museum addition on the south side of the building will minimize its distraction from the original structure. Because the lot is small, this museum addition will require the demolition of the three existing additions -- the woodshed, old boiler room and loading dock.

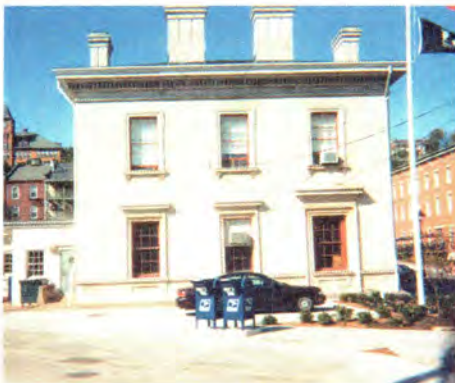
**Figure 7. East Elevation**

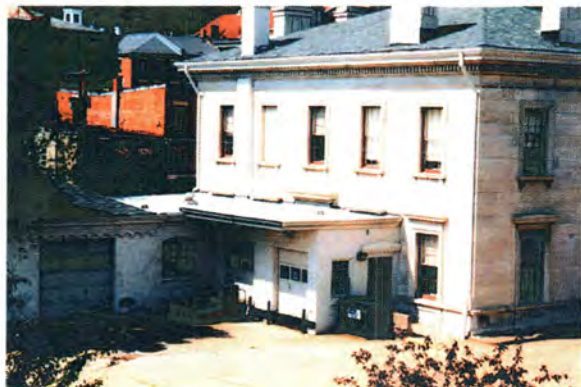
**Figure 8. South Elevation**

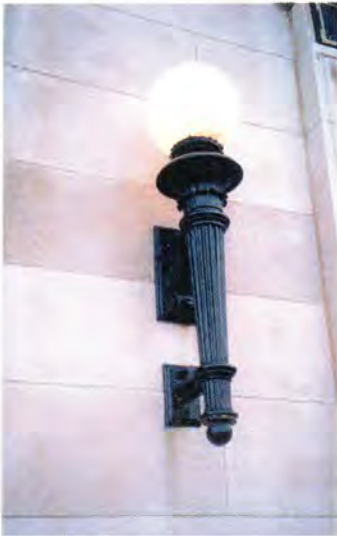
When electricity was supplied to the building in 1911, exterior wall mounted light fixtures were installed on either side of the two remaining lobby entrances (Figure 9).

**Figure 9. Exterior  
Light Fixture**

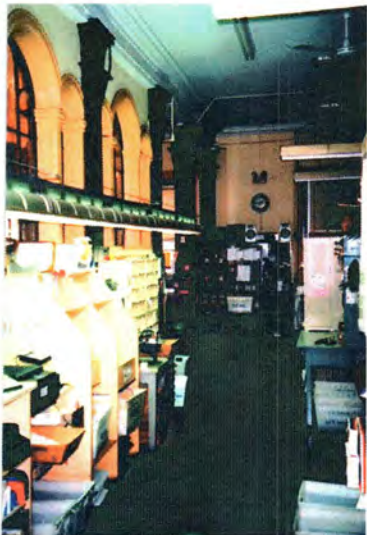
The mailroom is constantly changing based on postal functions (Figure 12). Ceiling mounted fluorescent light fixtures illuminate the work service for the postal employees. Ceiling mounted fans are installed for addition cooling purposes during the summer months.

**Figure 12. Mailroom**

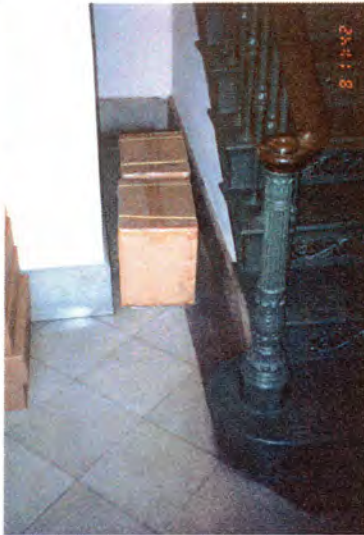
Two stamp vaults added in 1911 and 1924 replaced the original corridor (See Appendix A, "Drawing 2") on the first floor next to the original staircase (See Appendix C, "First Floor Plan"). A partial height wall supported the stair with exposed cast-iron trim running the length of the stair (See Appendix A, "Drawing 6"). The stamp vaults concealed the ornamental stair leading to the second floor (Figure 13).

**Figure 13. Stamp Vault  
Next to cast-iron stairs**

The historic stair located in the post office is constructed out of cast-iron, a generally soft material (Figure 13, 16 & 17). The cast-iron treads, risers, and rails have numerous layers of paint and the treads show slight wear marks. A trained professional shall administer the paint removal from the cast-iron pieces because of the air contaminants associated with cast-iron. Sample areas will be selected to apply three cleaning methods: wire brush, chemical stripper, and dry sandblasting. If one of the methods gently cleans without damaging the cast-iron, the entire stairs will be cleaned. The cleaned surface will be painted to match the 1980-paint analysis. The wood handrail will be removed and refinished to match the original finish.

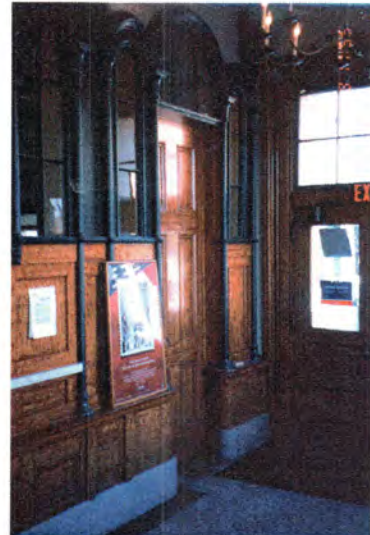
Between 1964 and 1980 a new postmaster's office was constructed on the west side of the mailroom. The door leading into the new postmaster's office from the lobby/vestibule is original to the building's construction (Figure 14). A small vestibule between the door and the stair is floored with limestone tiles, and the original chandelier, installed 1911, hangs

**Figure 14. Original  
Lobby/Vestibule Doorway**

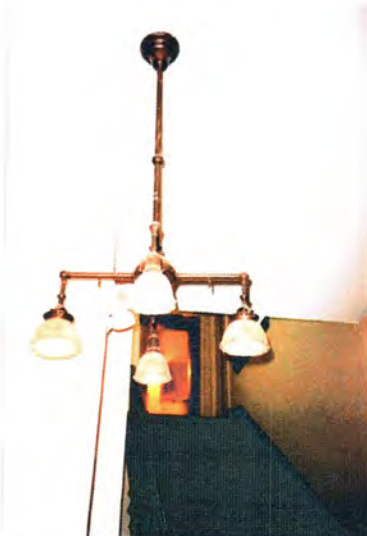
from the center of the vestibule ceiling (Figure 15).

**Figure 15. Original Stairwell Light Fixture**

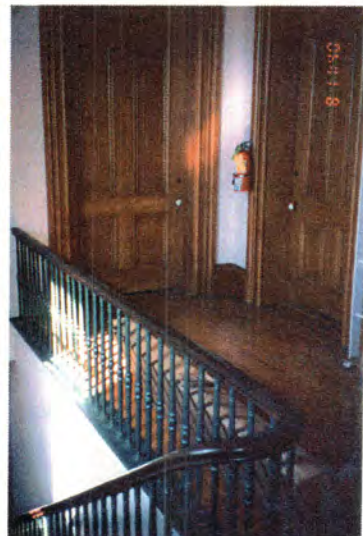
The original interior doors on the second floor are approximately ten feet tall and four feet wide (Figure 17). On the right hand side of the photograph is a ships ladder leading into the attic through a ceiling access panel.

**Figure 17. Second Floor Hall**

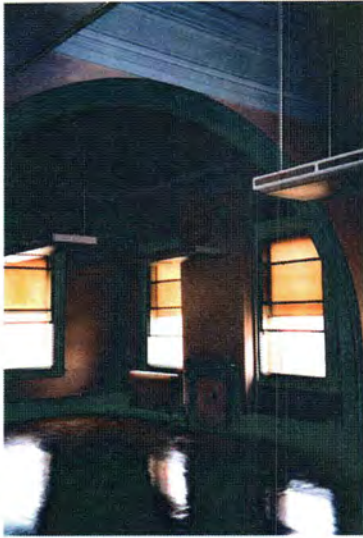
An interior wall was added prior to 1911 dividing the main custom room into a smaller main room and an additional office (See Appendix C, “Second Floor Plan”). Another wall was added in 1911 that had an arched opening dividing the main custom room once again (Figure 18).

**Figure 18. Second Floor Arched Opening**

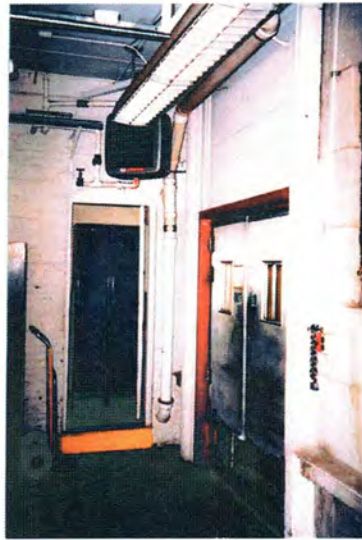
**Figure 19. Loading Dock looking West**

Approximately 1970, a loading dock was added to the south side of the post office. The addition did not impact the original windows designed by Young (Figure 19).

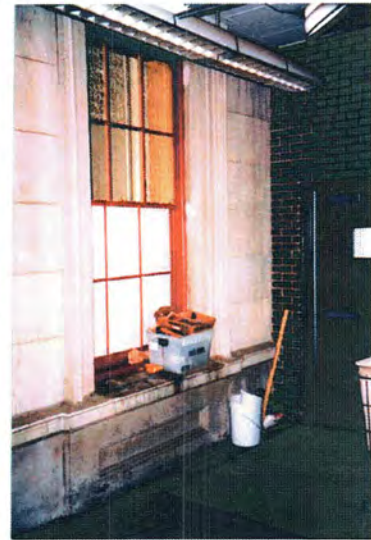
**Figure 20. Loading Dock looking East**

New loading dock doors were added for large mail deliveries. The new doors replaced the limestone trim with concrete block construction (Figure 20). Ceiling mounted fluorescent light fixtures illuminate the loading dock.

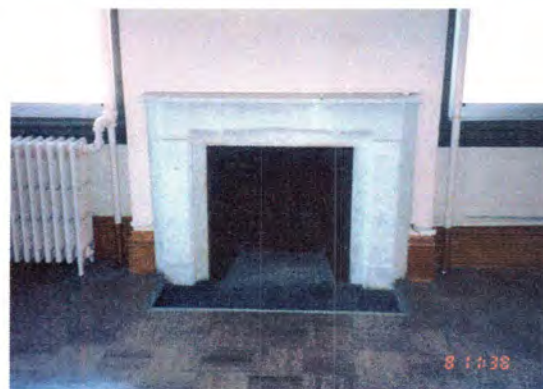
Originally, eight marble fireplaces heated the post office with wood stored in the brick woodshed on the neighboring property (Figure 21). In the late 1800s, a new boiler was installed with radiators located on the first and second floor of the post office.

**Figure 21. Second Floor Fireplace**

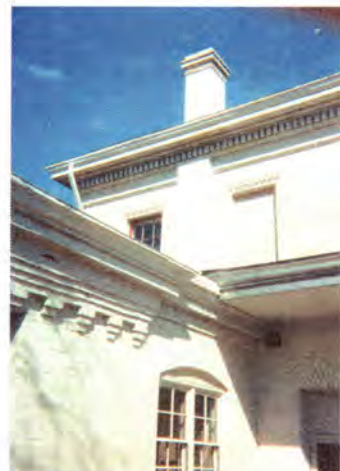
Preventing water damage is critical step in ensuring the longevity of a building. Beginning at the top of the building, the roofing system is the first line of defense against water damage. The roof has an asphalt-shingle system with flashing, gutters, and downspouts replaced approximately five years ago. The system is intact and could last another 10 years. Seven of the eight existing limestone chimneys have sustained water damage that has chipped away limestone and mortar joints. During the roof repairs the chimneys received new mortar preventing further water infiltration. The southwest chimney was replaced with brick and concrete similar in profile to the original chimneys (Figure 22).

**Figure 22. Southwest Chimney**

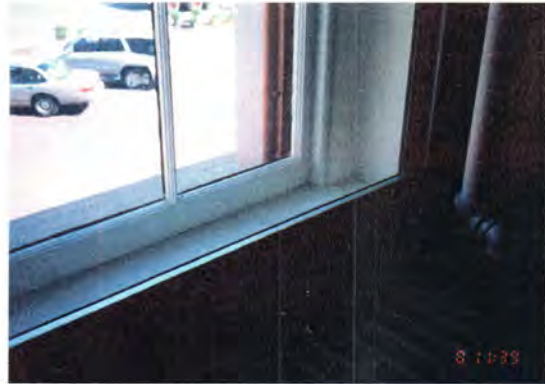
In 1998, the windowsills on second floor showed signs of water damage and the paint was chipping. The postal facilities have since caulked and sealed the windows against water damage. The chipped paint was removed and the cavities were filled with wood putty and sanded smooth (Figure 23). The interior window components were

**Figure 23. Repaired Windowsill**

then painted to match the 1980-paint analysis. The photograph shows the dual glass system preventing additional moisture from damaging the sill and window trim. The exterior window profile matches the original window (See Appendix A, “Drawing 7”).

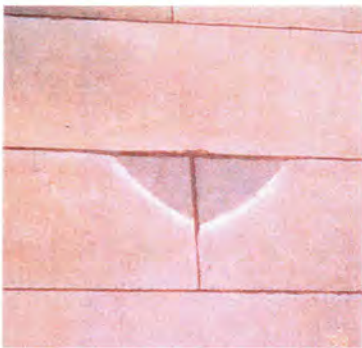
Approximately five years ago the façade of the post office and additions underwent selective limestone, brick, and mortar replacement and repair. The limestone façade has sustained soiling and signs of weathering. The freeze thaw cycle has cracked and deteriorated pieces of the limestone facade. Colored concrete matching the limestone was applied to the deteriorated pieces to create a new appearance (Figure 24). The loose mortar joints were replaced with new mortar matching the original color, texture, and application.

**Figure 24. Limestone Replacement**

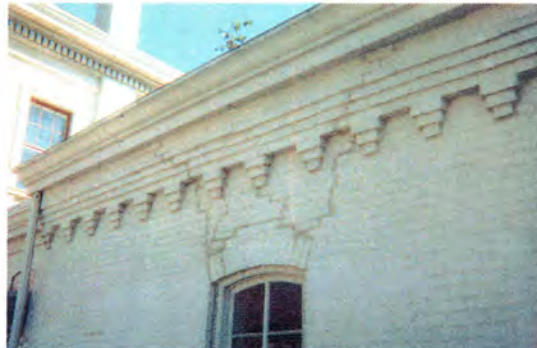
The façade of the additions are constructed of brick. The brick has undergone similar weathering as the limestone but also shows signs of exterior structural cracks in the façade. During the limestone restoration the brick façade was also repaired. Cracks in the brick were sealed with new mortar and the new joints were raked flush (Figure 25). The brick on the building received a fresh coat of paint, adding an additional level of waterproofing.

**Figure 25. Mortar Joints Replacement**

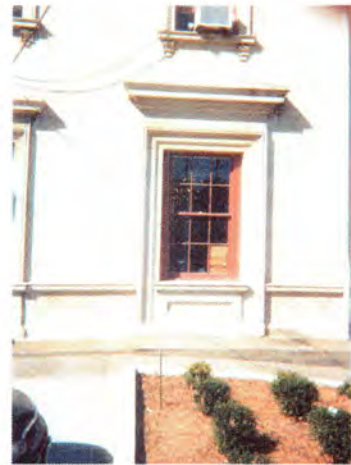
The lobby/vestibule is the most important public space within the 1858 Galena Historic Post Office/Customhouse (See Appendix A, “Drawing 2, Entrance Story Plan”). The lobby/vestibule originally had three entrances. One of the entrances was removed to enlarge the mailroom (Figure 26). The two remaining entrances are not handicap accessible because of the steps from the sidewalk to the first floor level. The renovated entrance is located on an inconspicuous side of the building allowing for a handicap entrance without modifying the two existing historical entrances. The design for replacement of the original entry will provide handicap access to the service windows and post office boxes and compliment the historical character of the building.

**Figure 26. Renovated East Entrance**

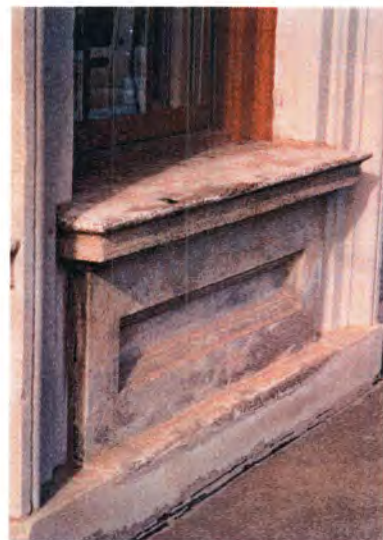
A concrete windowsill and window replaced the original northeast entrance (Figure 27). Removing the concrete windowsill and replacing the window with a pair of doors similar to the existing northwest entrance will allow for a new handicap accessible entrance. Historical evidence in the original drawings substantiate the design for replacement of the historic entrance similar to the northwest entrance (See Appendix A, “Drawing 2 & 5”). Restoring the east entrance will also require the relocation of the existing screen wall to its original position (See Appendix F, “First Floor Plan”). The dashed lines in the rehabilitation drawing indicate the portion of screen wall to be relocated. An additional

**Figure 27. East Entrance Window Replacement**
